WHEN FIELD PERFORMANCE OF MASONRY DOES NOT CORRELATE WITH LAB TEST RESULTS

Historic High School

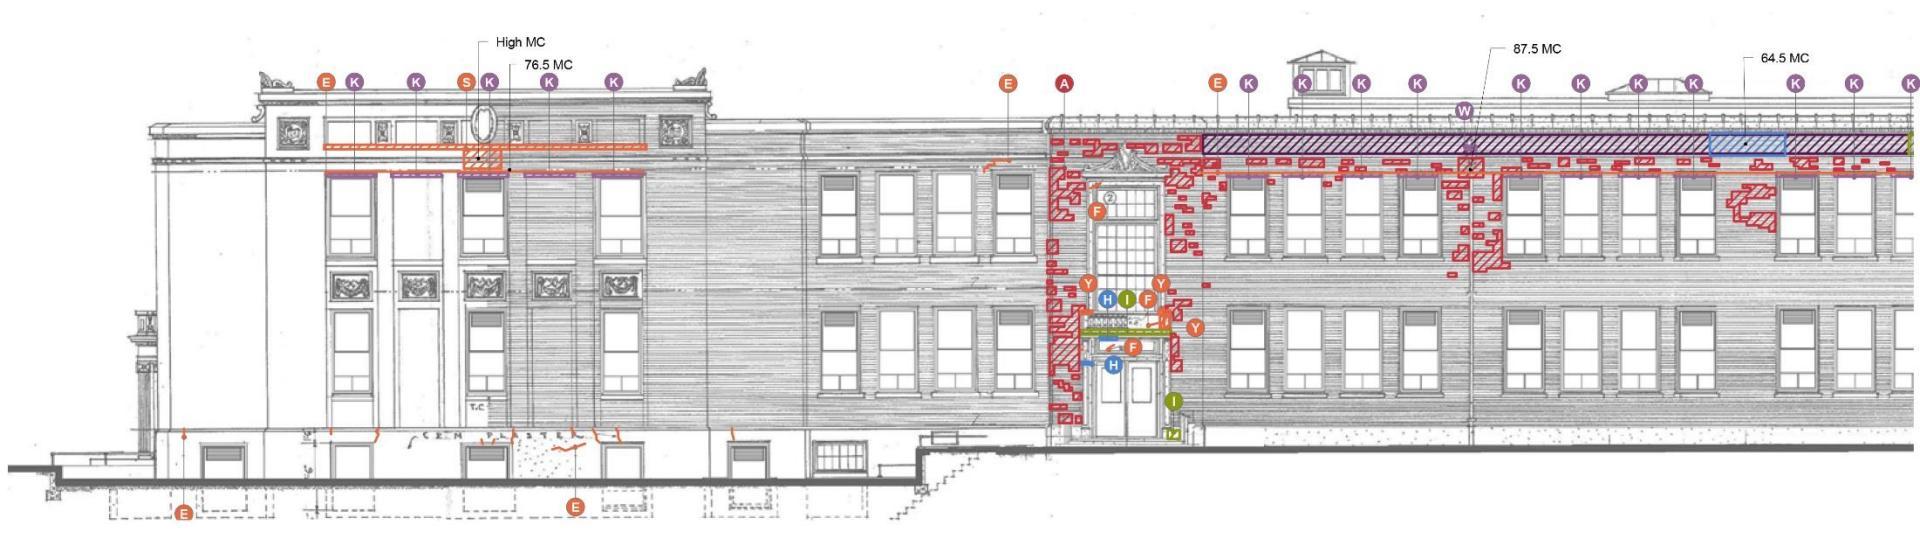
Extent of Problem – Clear limit

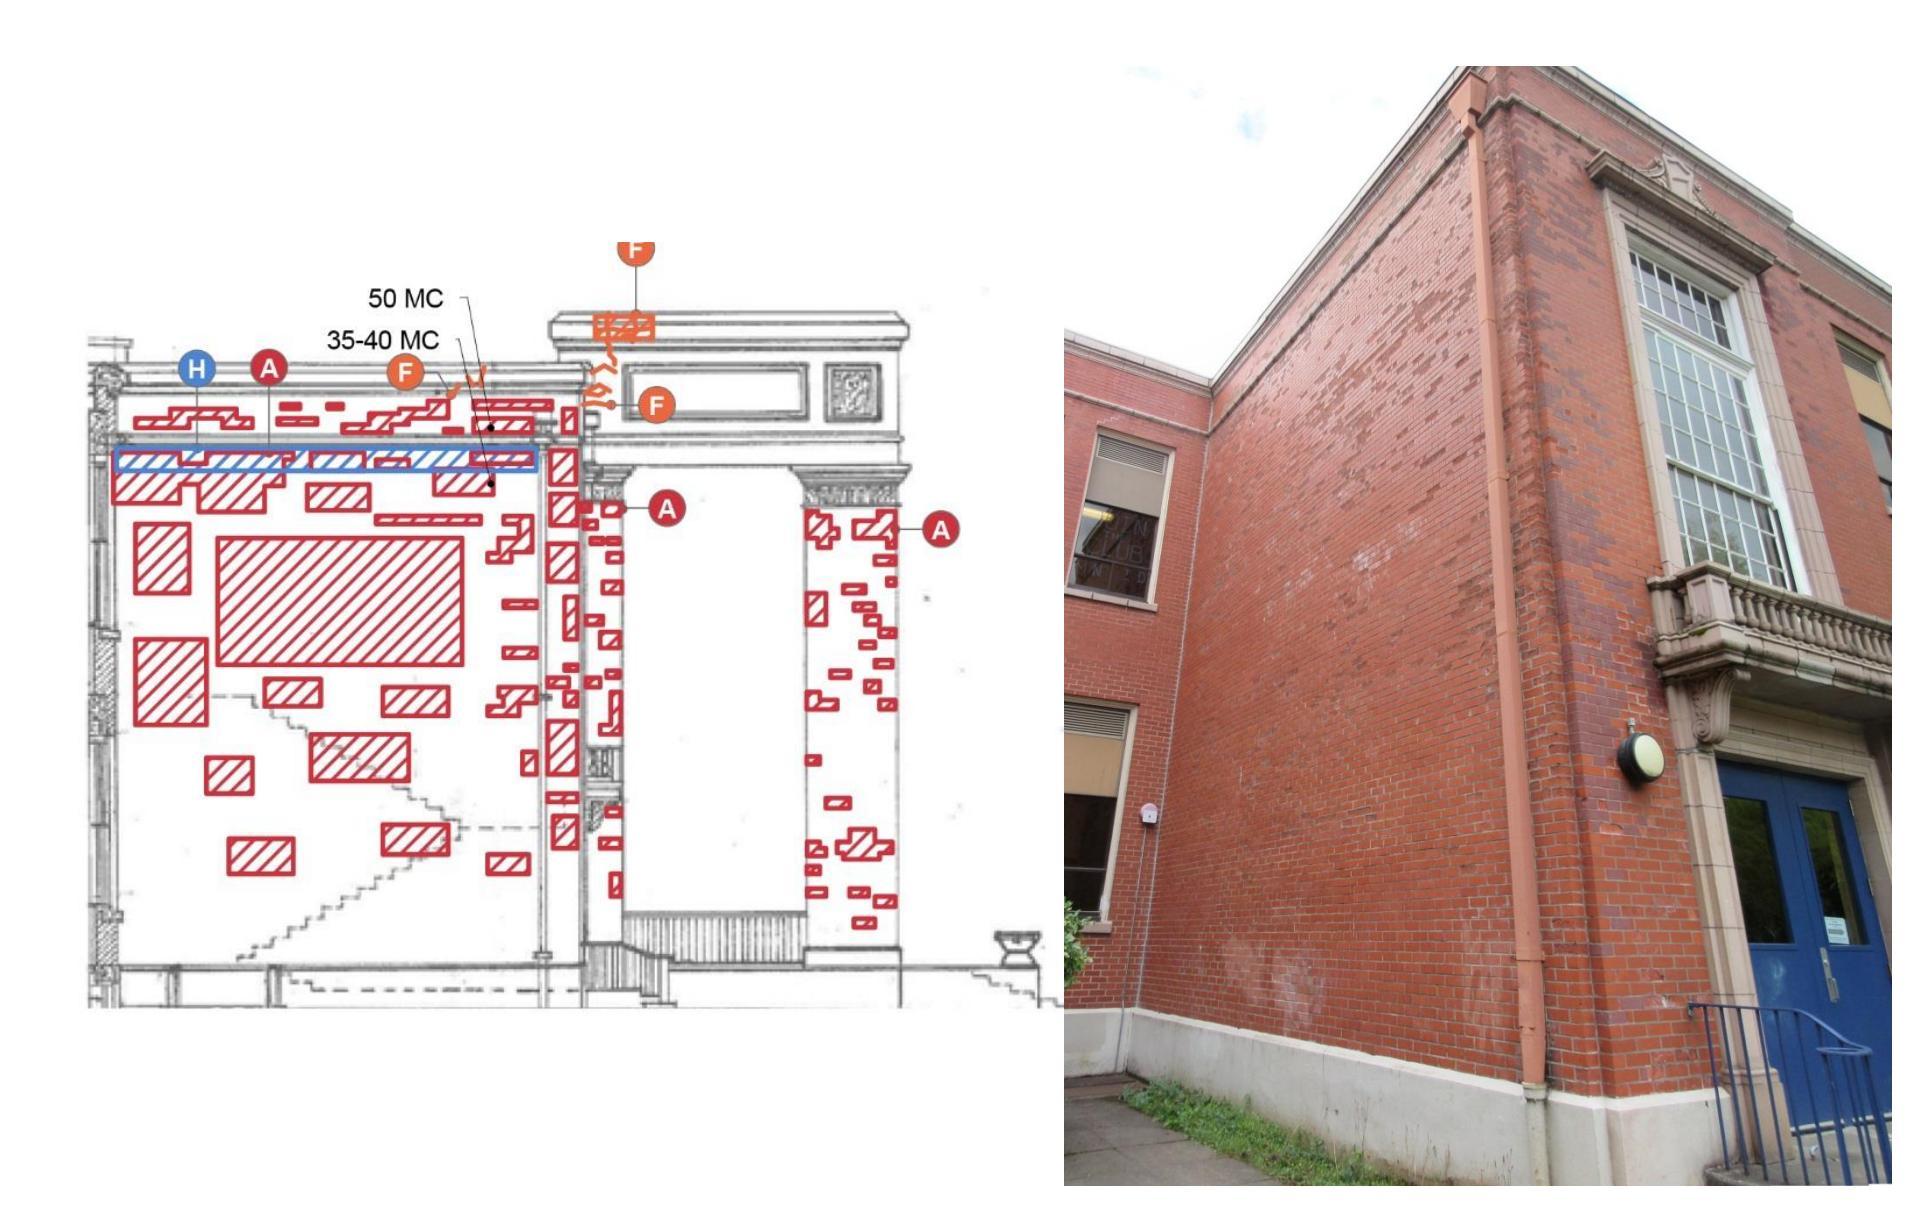
Extent of Problem – protected area

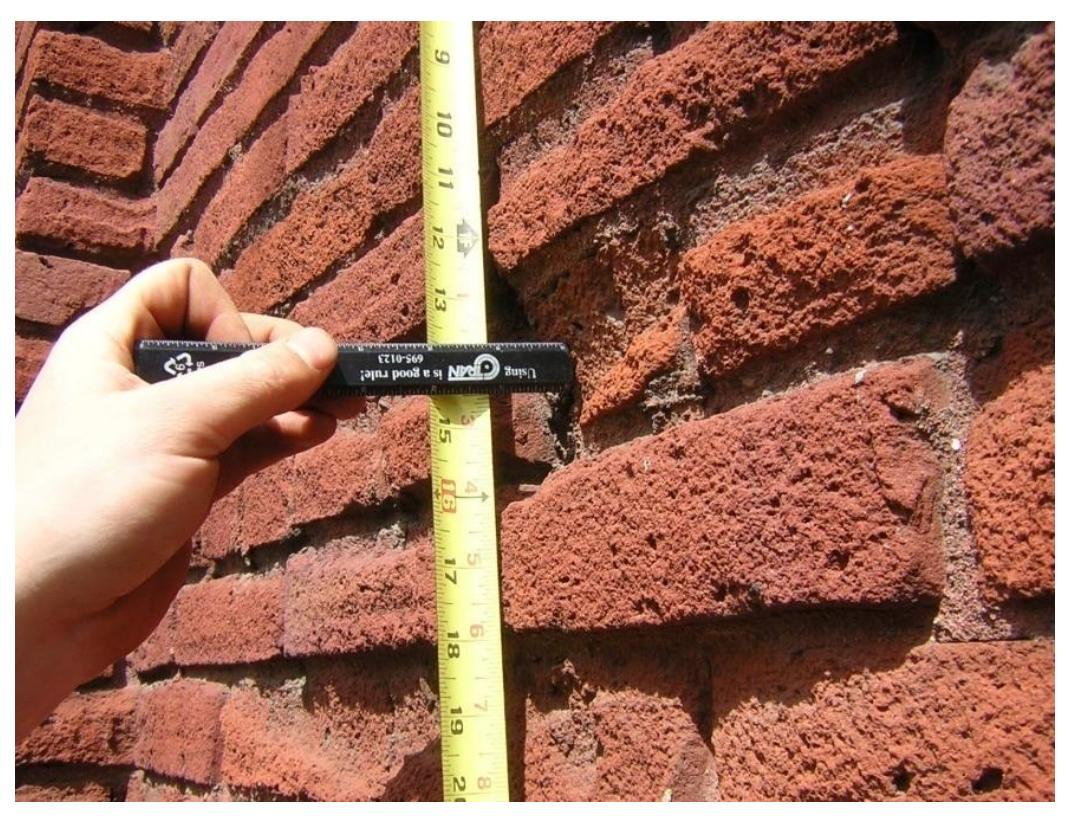
Mercy Corps HQ, Portland Oregon – Historic wing

Cracking

Poor firing; Fast cooling

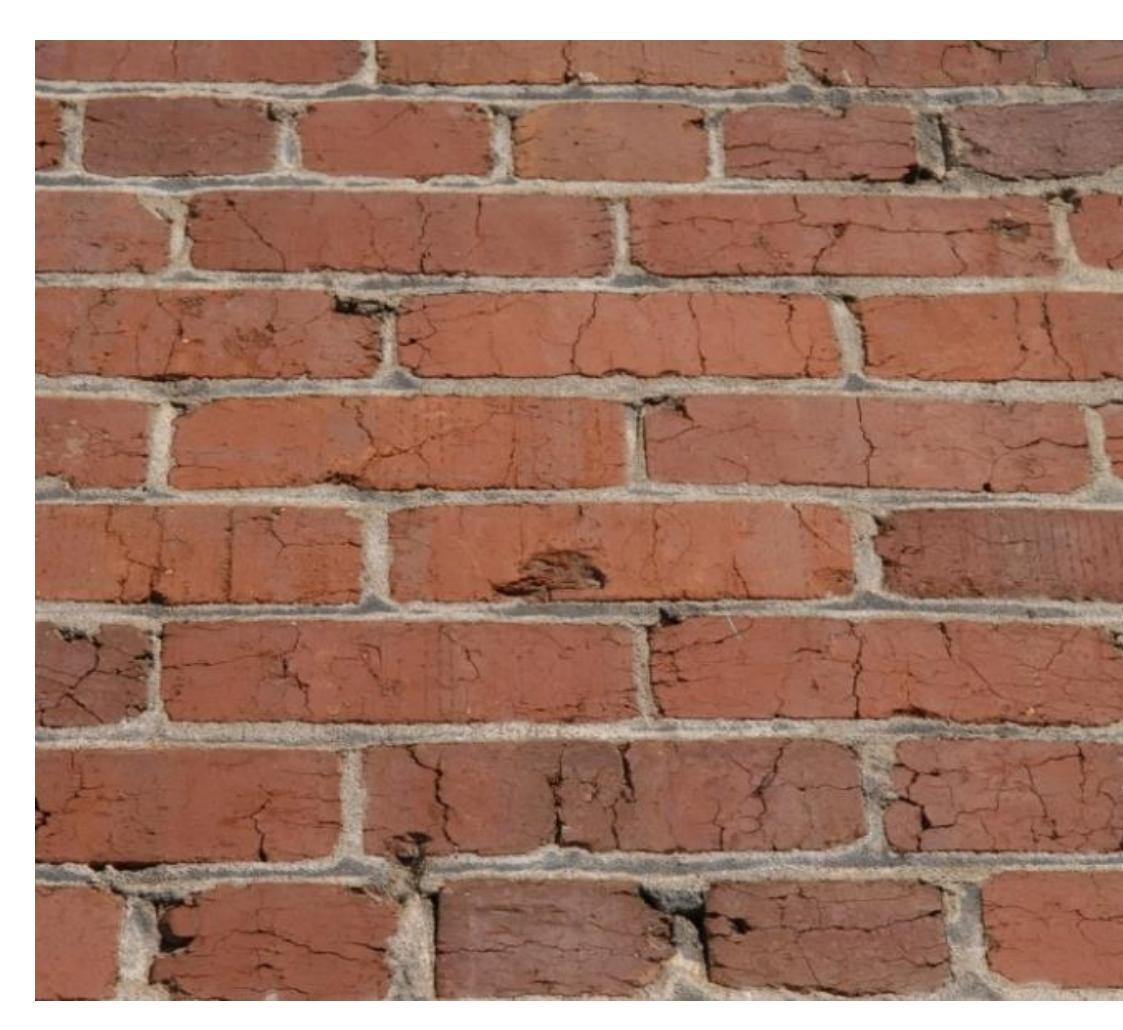
Roosevelt Middle School, Medford Oregon

Discoloring

Impurities

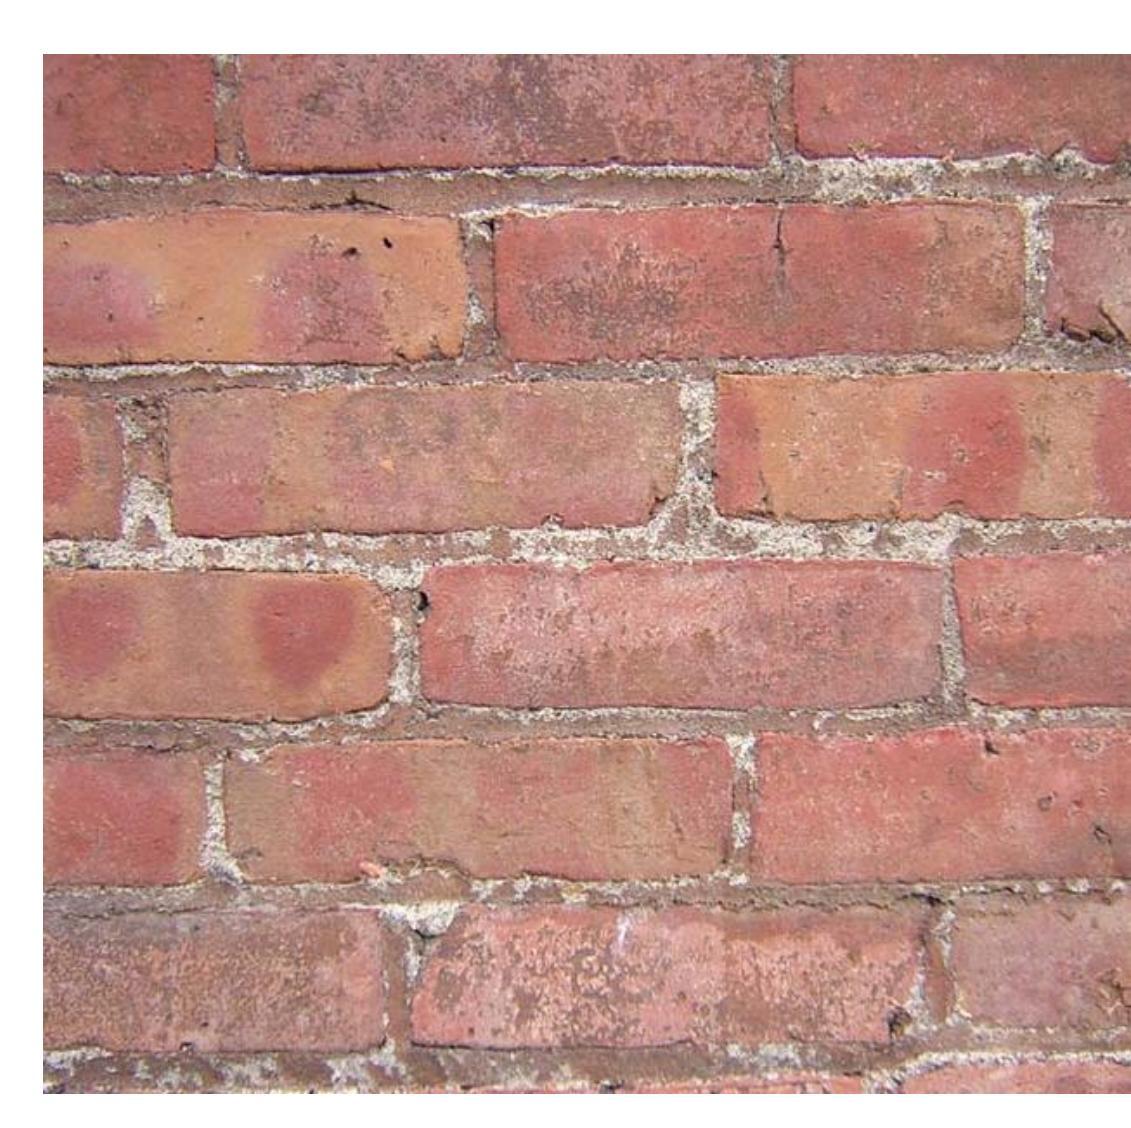
WSU, Spokane Washington

Deformities Poor Firing

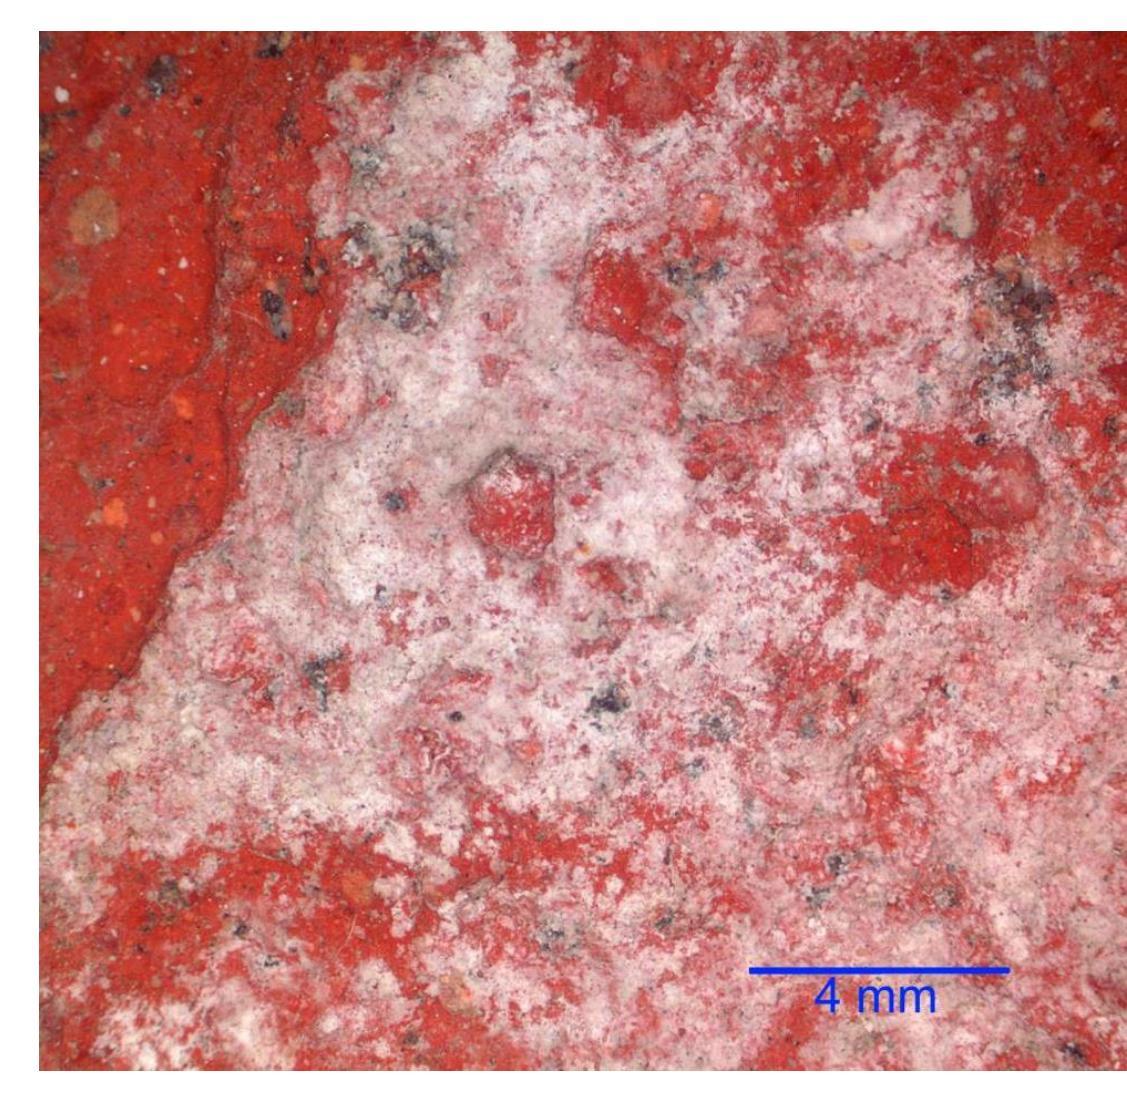
Mortar Sample

High magnification photo shows more detail on the **porosity** within the cementing matrix. This type of porosity looks as though it formed after formulation of the mortar and could be due to **dissolution of unstable granular**

components. If so, then the increased porosity of the interior of the mortar may be related to water movement through the mortar .

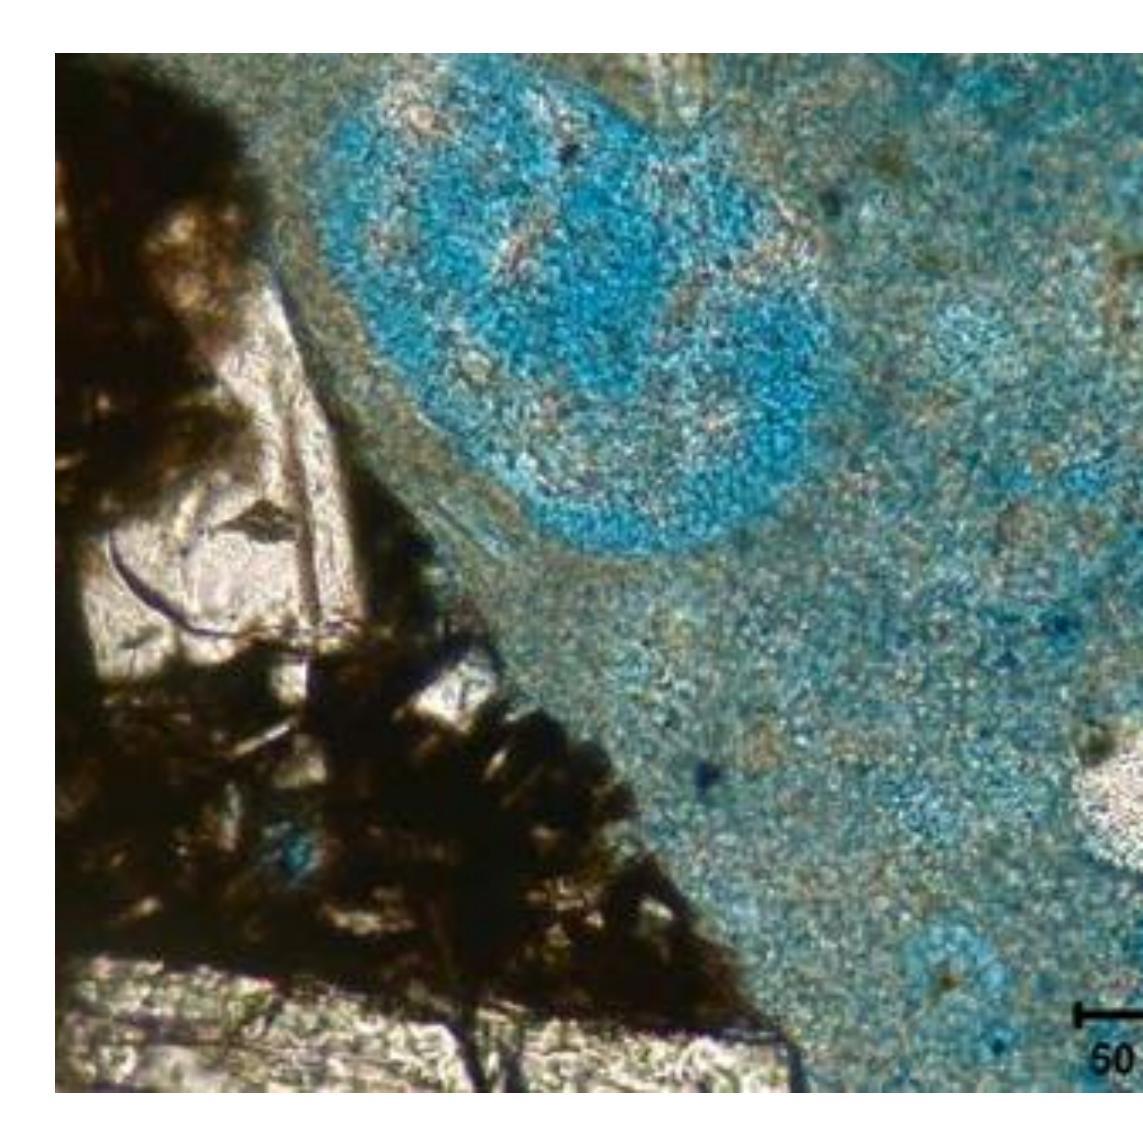
Mortar Sample

the total **porosity of the interior** of this mortar sample is about 3X that of the outer edge of the sample. The **reduced porosity** of the outer edge of the mortar could be a function of smearing of the **exposed joint** during finishing of the mortar. External pressure on the mortar surface would probably reduce the porosity of a thin zone.

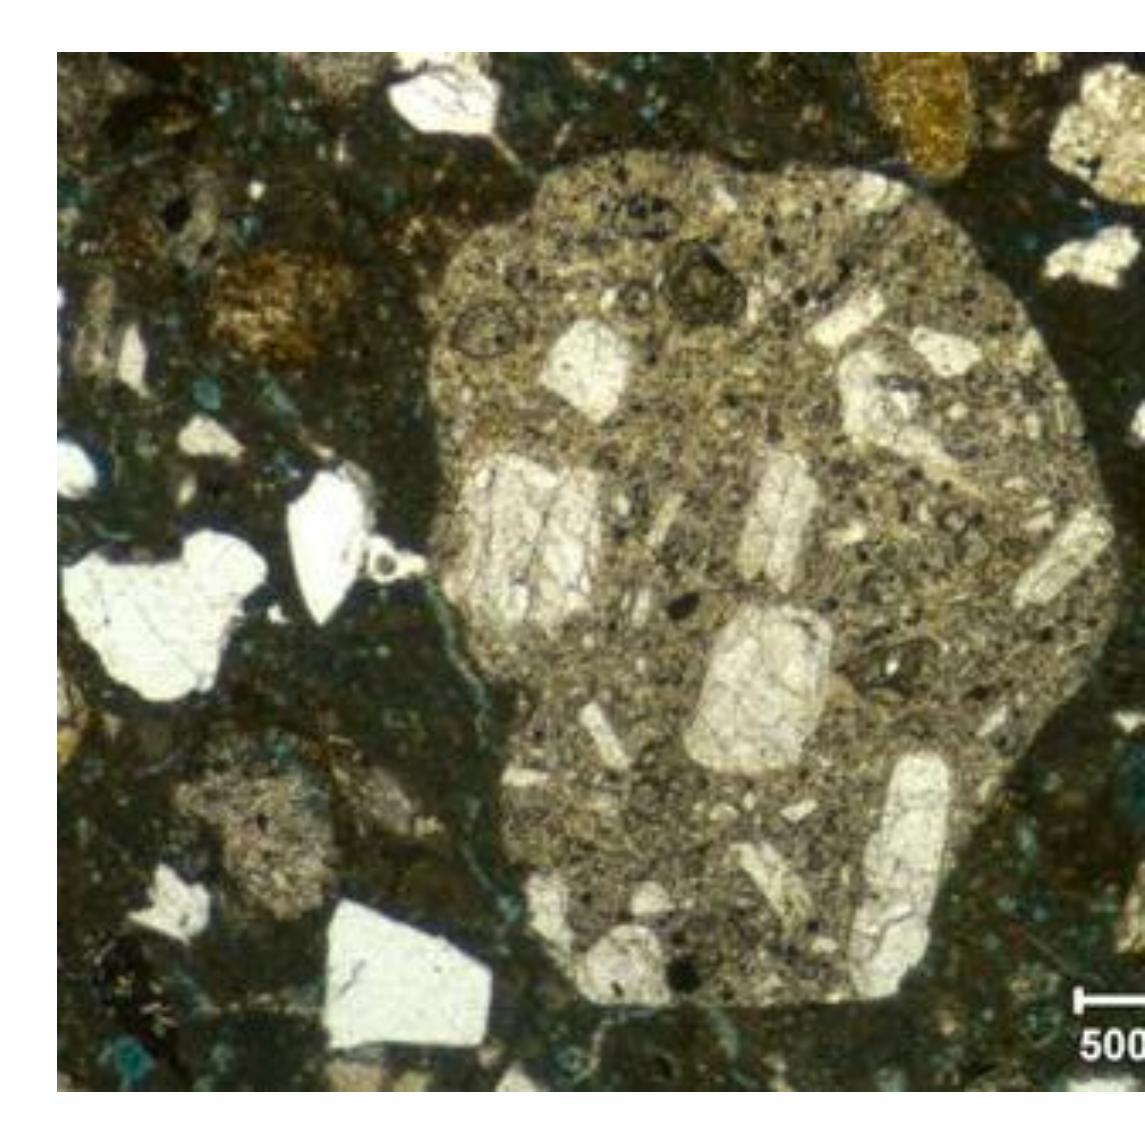
Mortar Sample

The primary **difference** between the edge mortar and the internal mortar is related to the amount of porosity in the **cement matrix**. The edge mortar shows only about 3% porosity, whereas the interior cement has nearly 8% porosity

The lime : aggregate ratio of this sample is about 48:52, or nearly 1:1, after removing minor amounts of porosity .

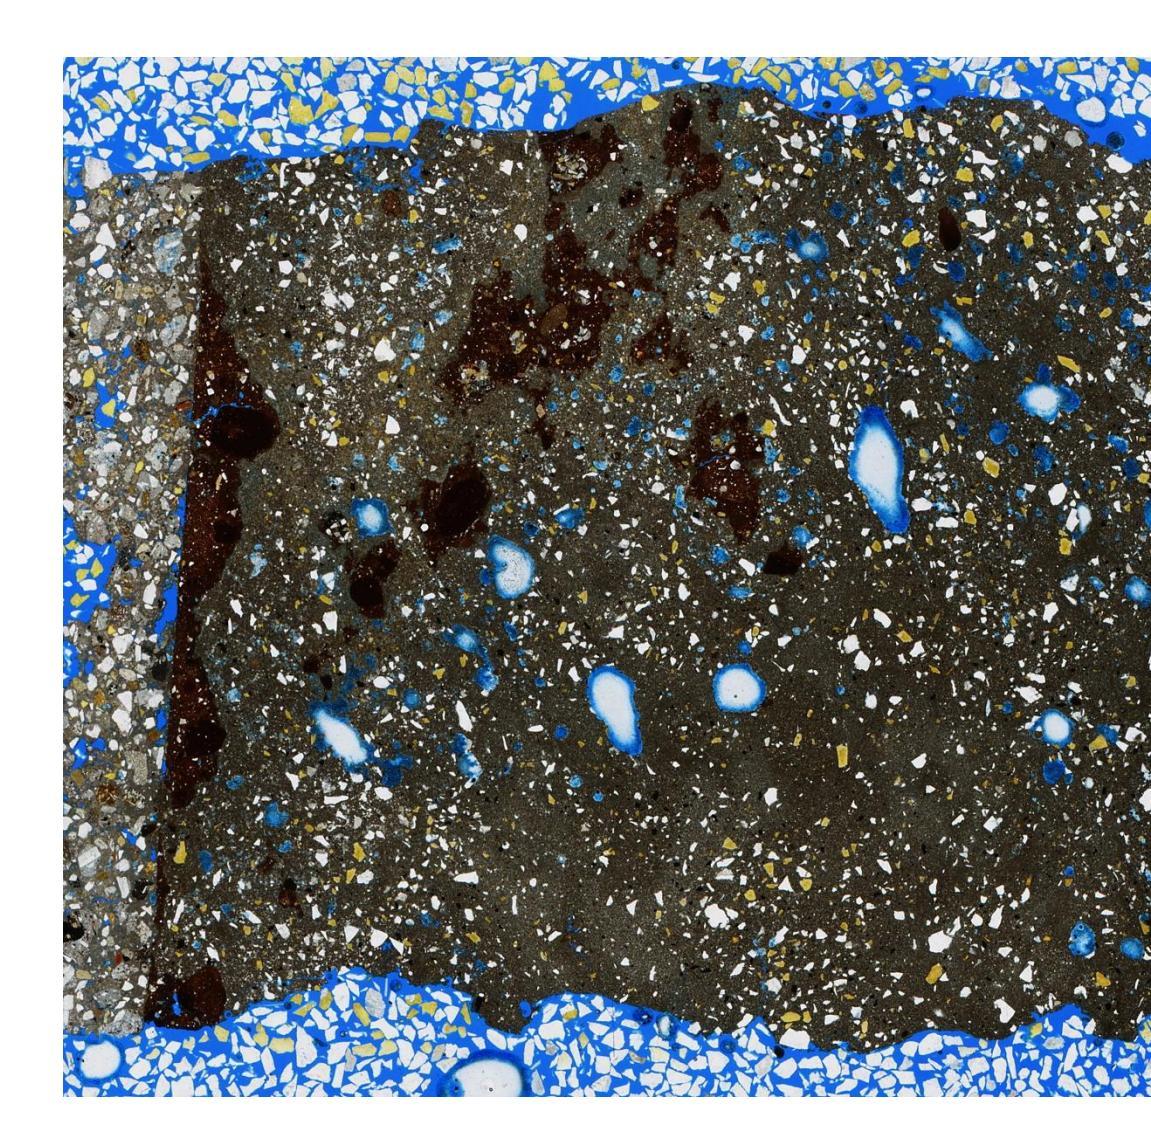
Brick sample #3

The brick is transected by numerous planar and irregular voids that are often interconnected and provide pathways for water percolation through the brick, as well as possible locations for freeze/thaw damage. The center of the thin section shows a zone with complex interconnected porosity (blue areas) that may have developed during firing of the clay (shrinkage cracks). The common occurrence of large planar voids contributes to an increased risk of brick failure along these surfaces.
