# HISTORICAL ANALYSIS

## HISTORICAL ANALYSIS EXTERIOR ELEVATIONS

## HISTORICAL ANALYSIS INTERIOR FLOOR PLANS

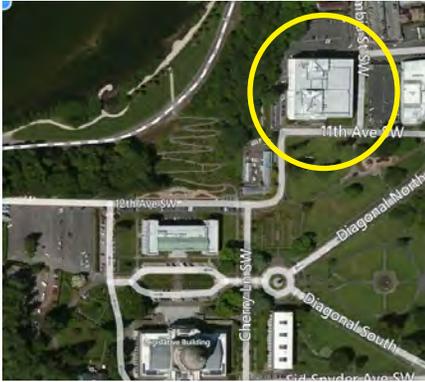
Current aerial view

The General Administration (GA) building is bordered by 11th Avenue SW on the south, Columbia Street SW on the east, a concrete surface parking lot on the north, and a vegetated slope at the northwest corner and along the west. Views from upper levels of the building overlook the north end of Capitol Lake. The Capitol Conservatory and greenhouses, along with the Sunken Garden and Washington Supreme Court building are located nearby to the southwest of the GA Building.

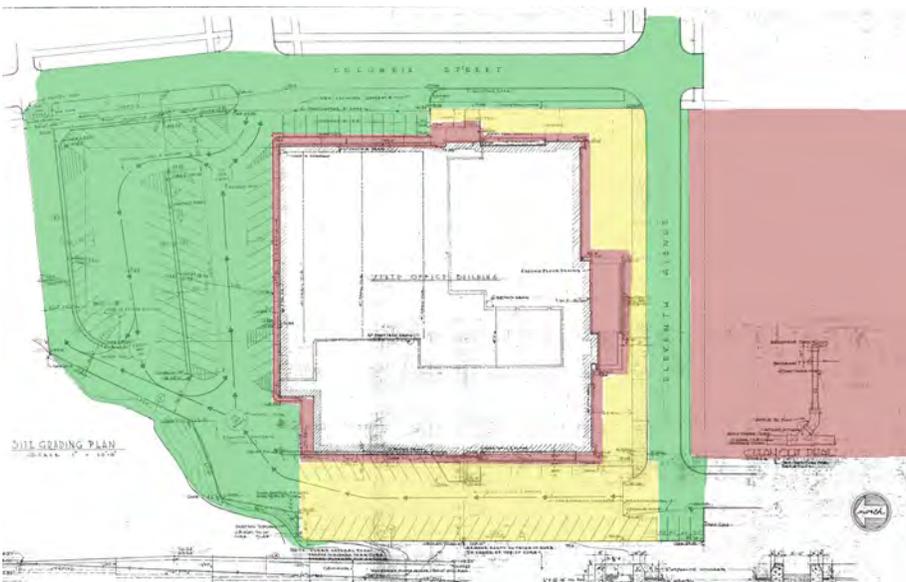
SITE PLAN

- Perimeter of building
- Open space/formal landscape to south of building

- Entrance patio (off south)
- West drive and parking lot

- Sloped Landscape
- Rear (north) parking lot
- Streets/sidewalks

The site would be visually impacted if new construction were to occur on the lawn that would detract from the building's visual presence as a significant resource on the Capitol campus.

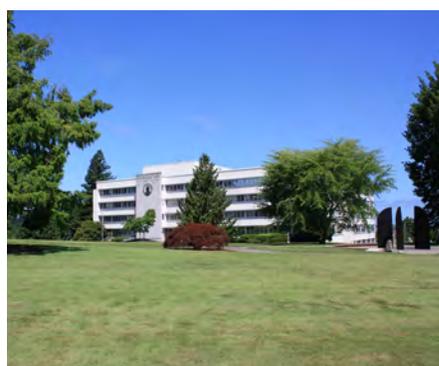
Overall, the site reflects the Capitol campus setting that existed in 1956 when the building was constructed. A large formal lawn with mature trees creates a wide buffer of open space along the south edge of the building. The lawn provides views of the building's south (front) facade, particularly the sandstone pylon and Washington State seal. A World War II memorial, designed by Simon Kogan and dedicated in 1999, has been installed near the northeast edge of the lawn.

Current setting and landscape

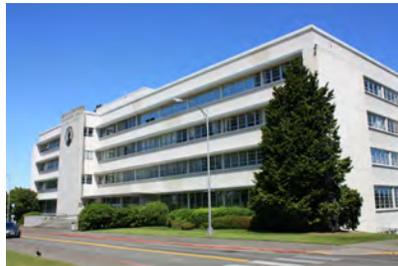
South elevation

The GA building's International Modern design is primarily characterized by exterior design elements. The overall form and massing of the 4+ story building is defined by its horizontal emphasis, created by bands of multi-pane aluminum hopper windows, etched concrete panels, and inset boxed ledge canopies. Large, slightly projecting vertical elements interrupt the horizontal bands on each facade, although the most prominent and ornamental is the sandstone pylon with the Washington State seal on the south elevation. The rear stairwell and penthouse exterior comprise this vertical design element on the north elevation. Although each facade is slightly different, the materials and overall design concepts remain consistent on all elevations of the building. These key character-defining features are to remain unaltered in a building renovation.

- Wilkesen sandstone pylon (high)
- Washington State Seal (high)
- Entrance location (high)

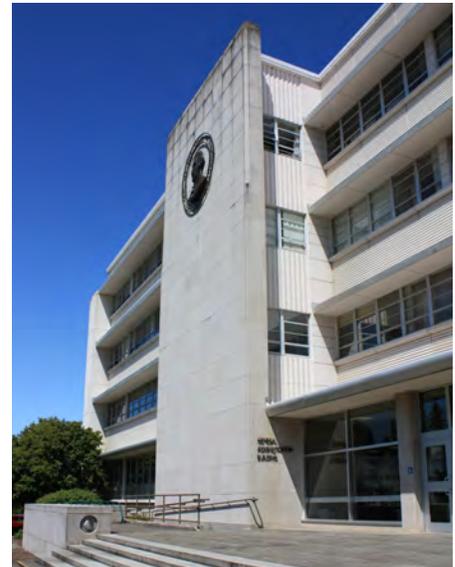
Main entrance

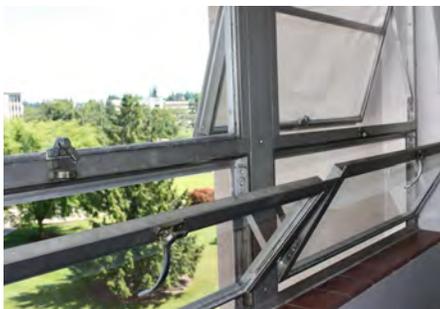
Window detail

Preservation standards would not necessarily inhibit alterations to specific materials, but instead would require that the overall design concepts are retained. Window replacement, for example, would require retaining the original window openings and horizontal bands of lights, but the window materials could be replaced with a more energy efficient multi-pane aluminum or other metal window.

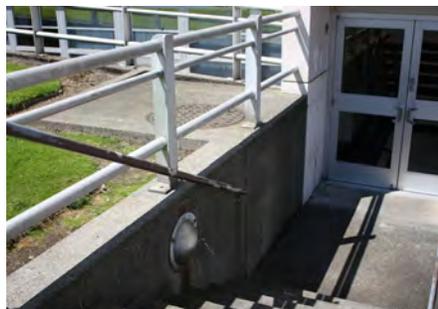
Holocene light and secondary entrance

- Window materials (although aluminum or other metal replacements would be recommended)
- Penthouses
- Entrance doors
- Convex Holocene lights

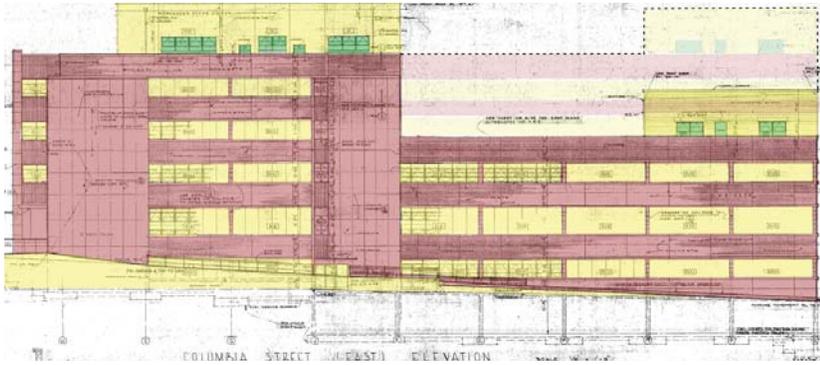
**EAST ELEVATION**

- Sloped Landscape (medium)
- Ground floor entrance (medium)

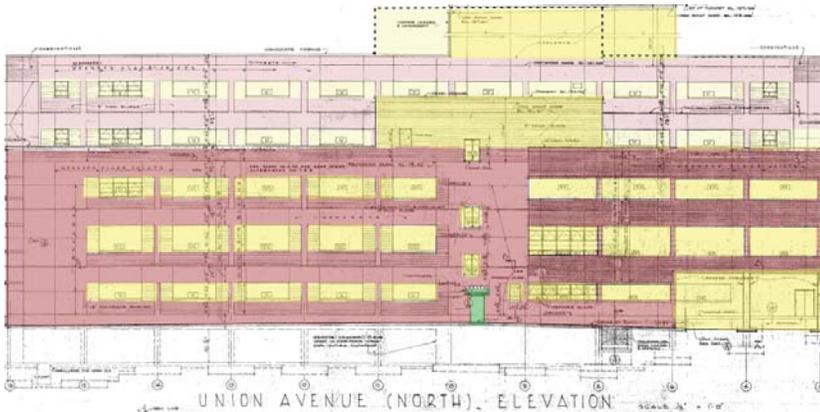
**NORTH ELEVATION**

- Verticality of stairwell shaft and penthouse (high)
- Loading dock (medium)

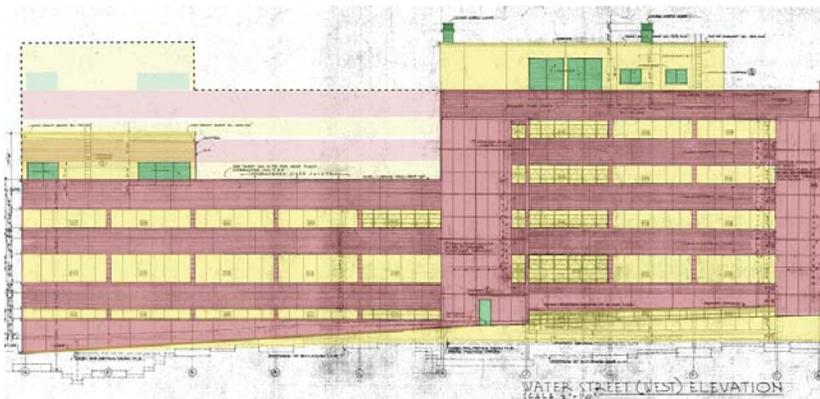
**WEST ELEVATION**

- Sloped landscape (medium)

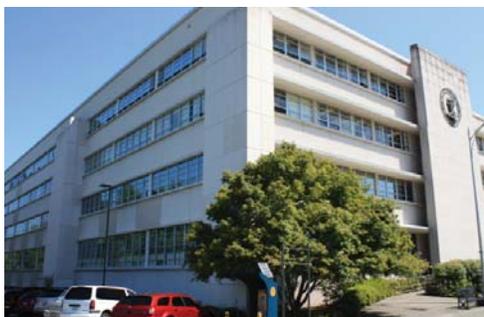
*West elevation*

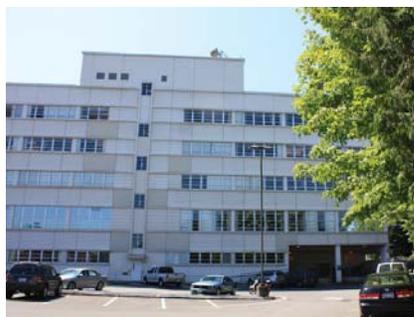
*North elevation*

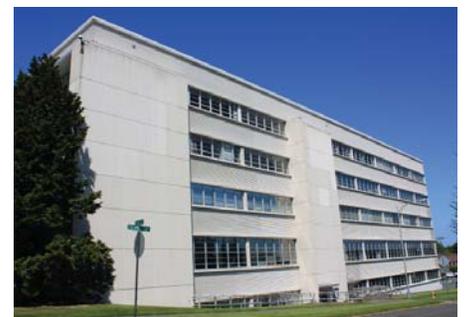
*East elevation*

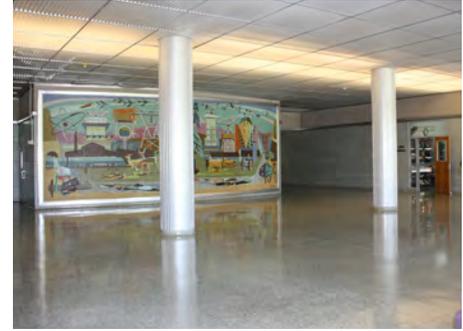
The main lobby and conference room on the first floor embody unique design elements that characterize the building. These spaces are to be considered with high preservation priority. Alterations to the lobby will be strictly reviewed and should be extremely limited.

*Entrance lobby and mosaic mural*

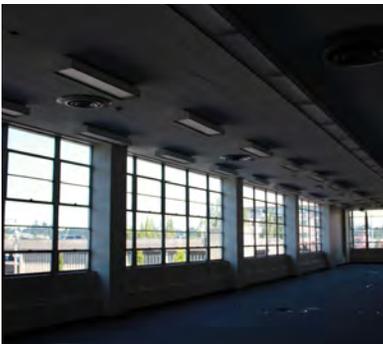
*Typical office and view*

The building's flexible wall configuration is a significant element of the building, intended to maintain a flexible floor plan without adhering to strict or consistent design principles. The movable walls are of medium preservation priority. This priority does not require that all moveable walls be retained in their current locations, but selective areas should maintain this historic design element, particularly in areas that may be more utilized by the public in the future.

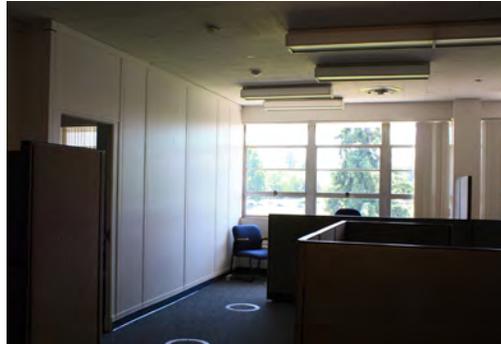
*Typical office with moveable walls*
