WHEN FIELD PERFORMANCE OF MASONRY DOES NOT CORRELATE WITH LAB TEST RESULTS

Historic High School

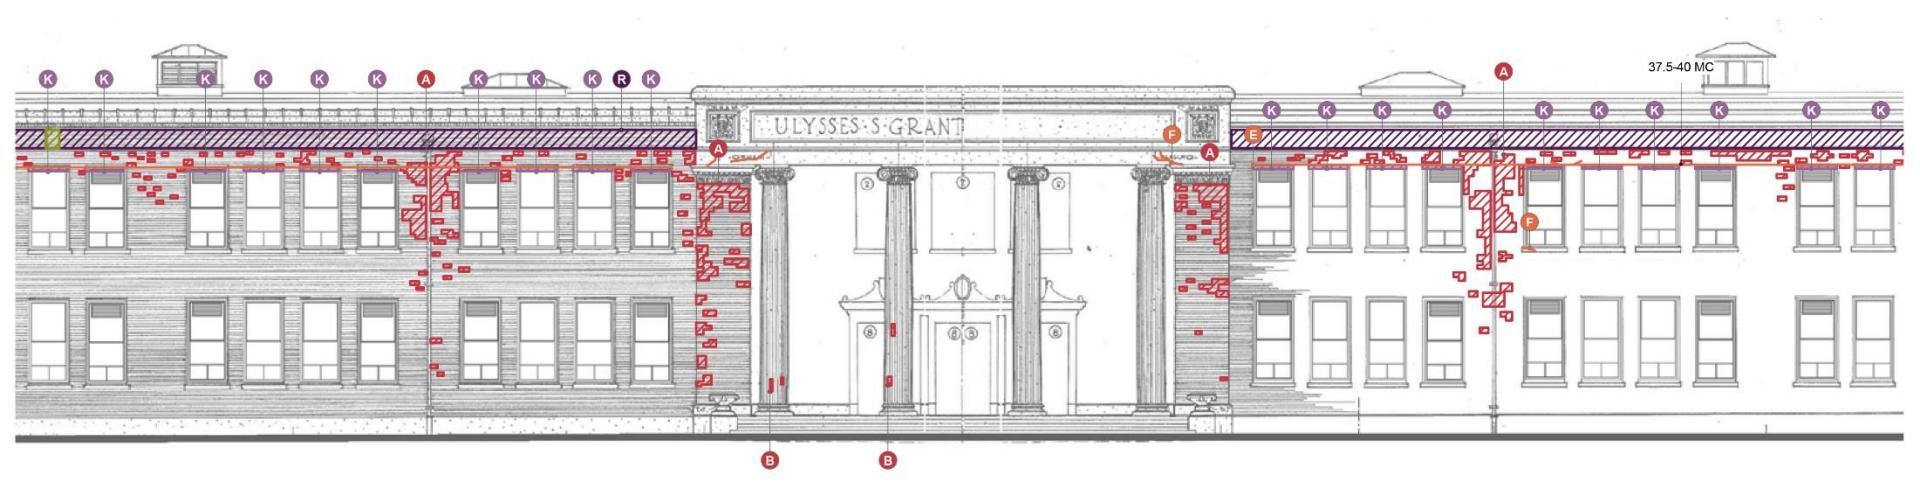
Extent of Problem

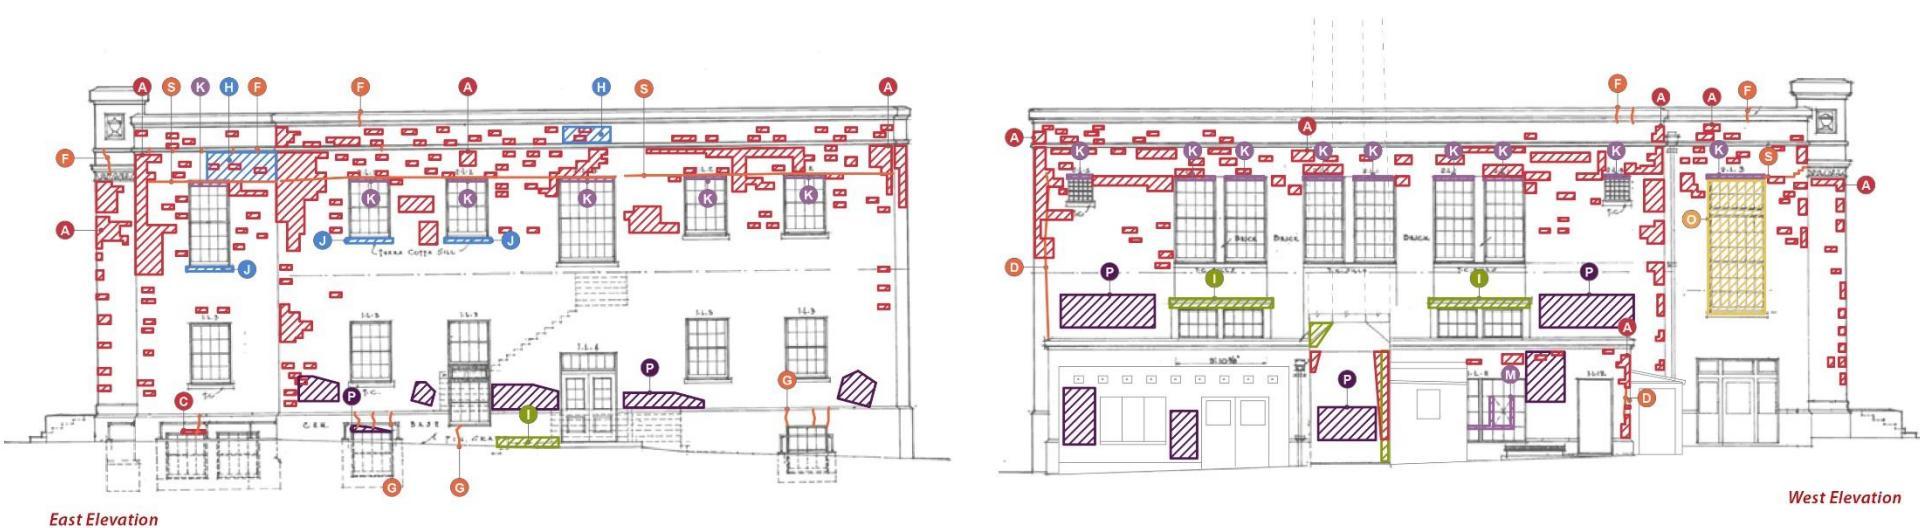
Extent of Problem – protected area

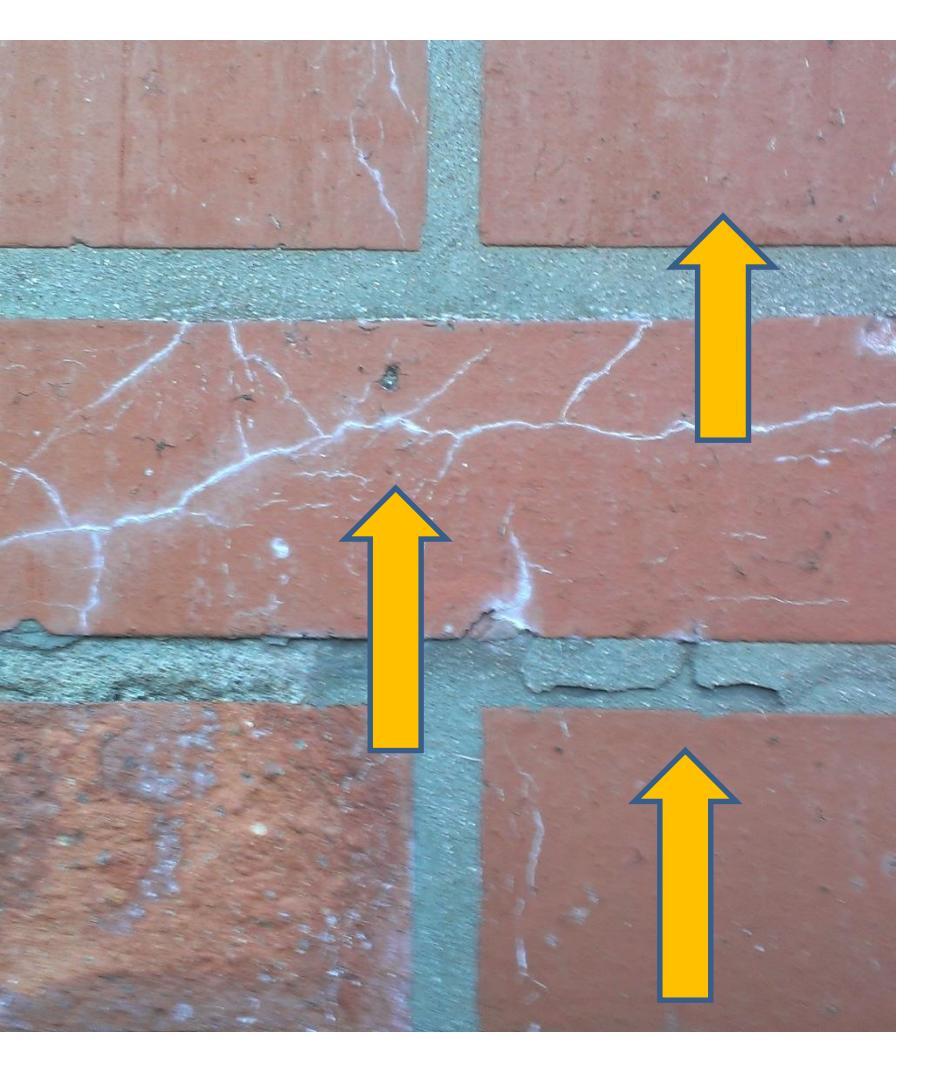
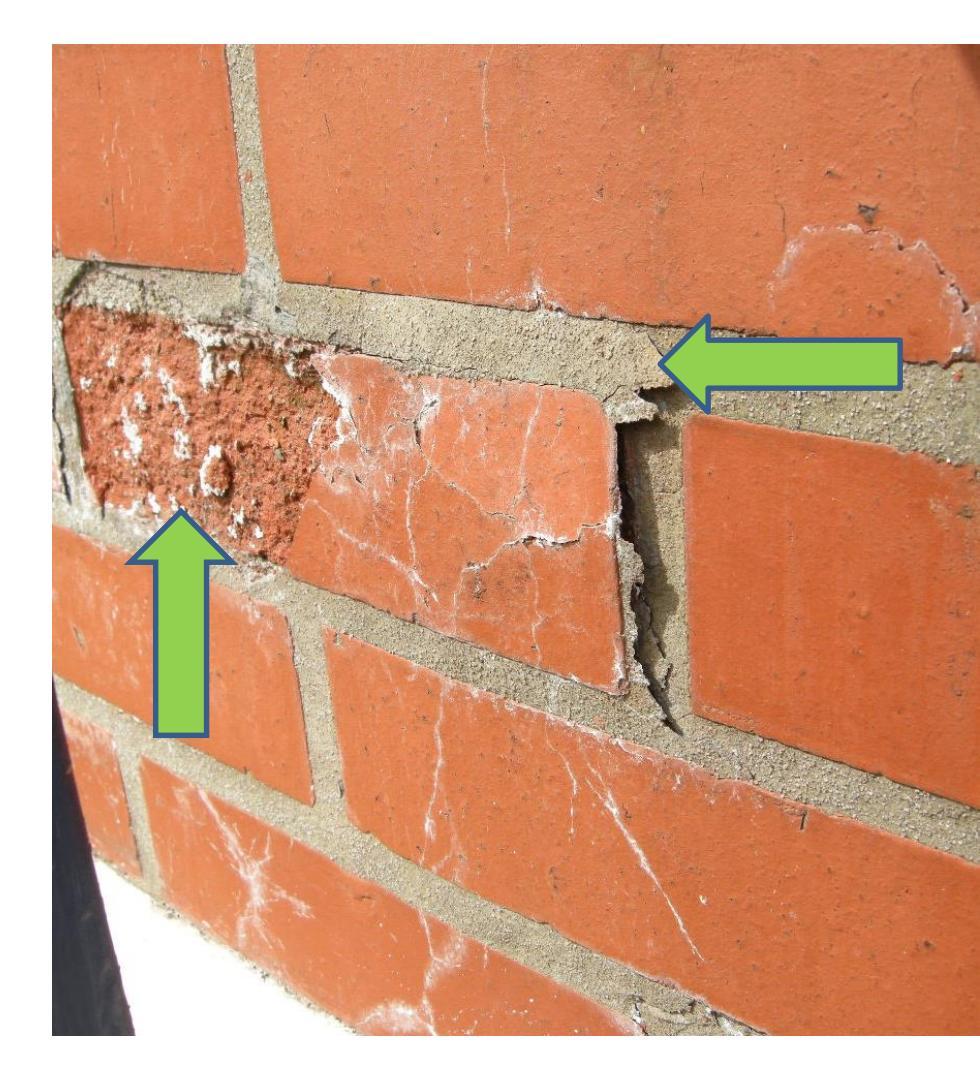
Exterior Visible Damage

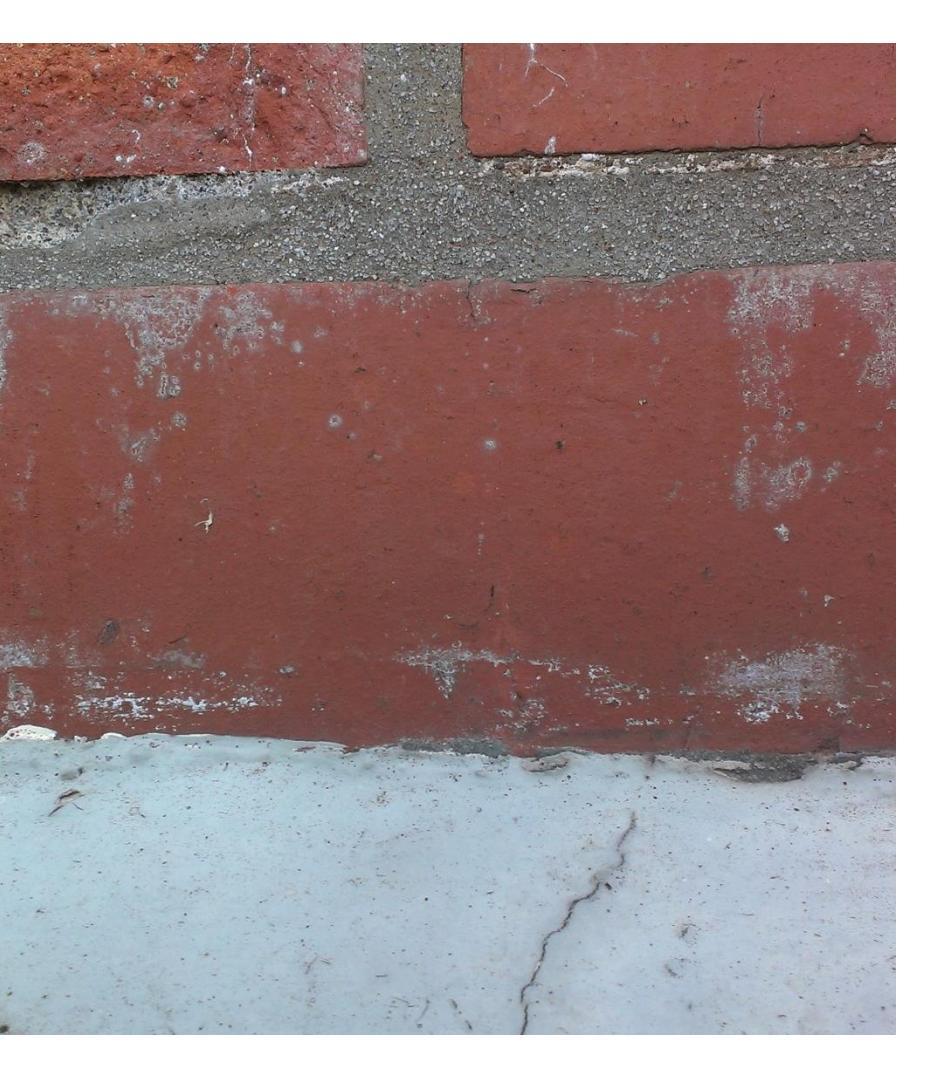
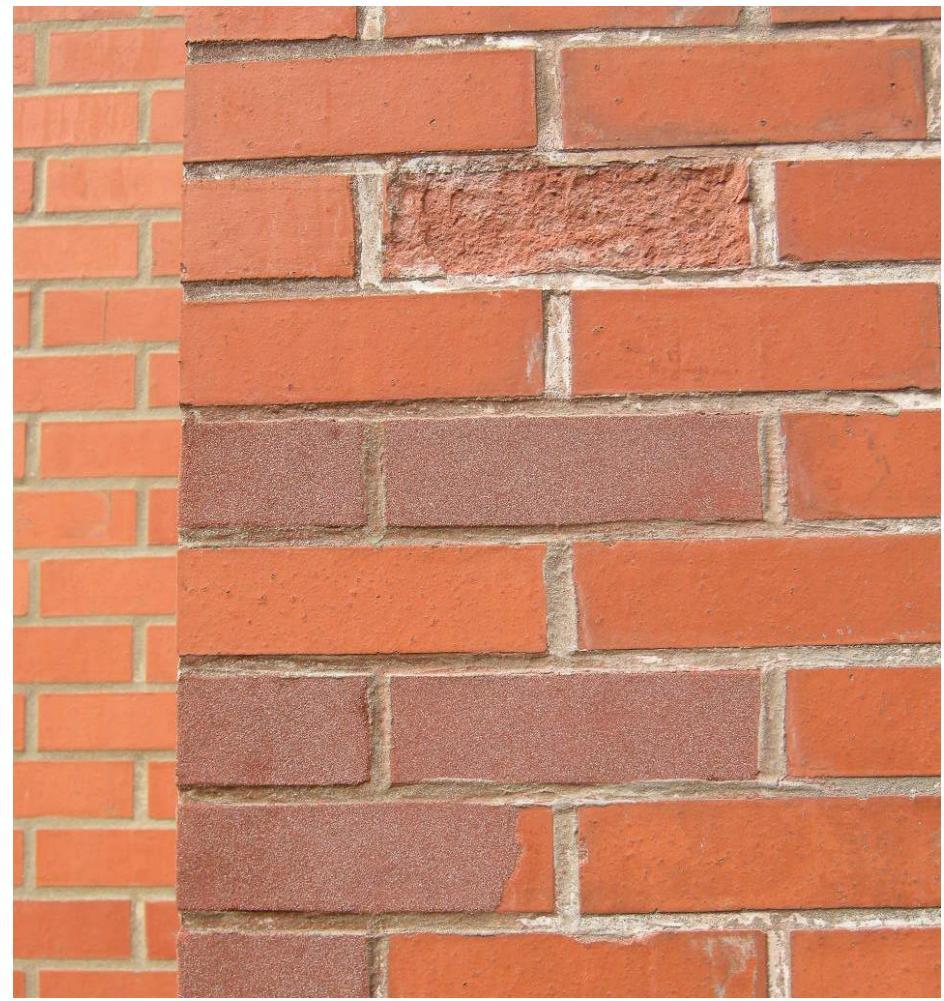
Exterior Visible Damage

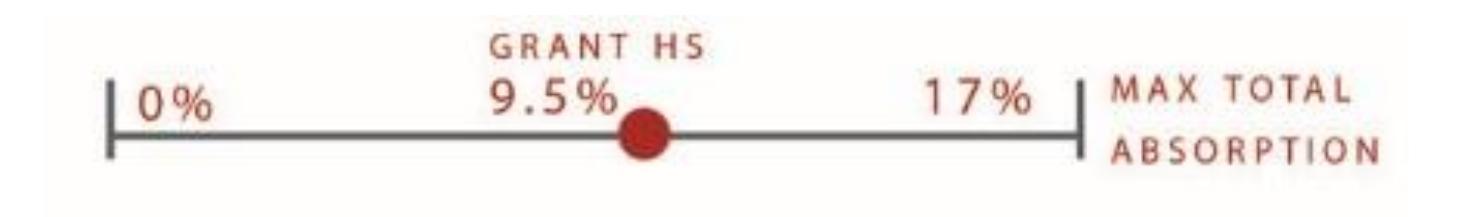
ASTM C 67 – Physical Analysis of Clay Face Brick

Unit No.	<u>1A</u>	<u>2A</u>	<u>3A</u>	<u>4A</u>	<u>5A</u>	AVG
Dimensions (as tested) Length (inches) Width (inches) Height (inches)	3.9 3.9 2.3	3.9 3.8 2.3	3.9 4.0 2.3	3.9 3.9 2.3	3.9 3.9 2.3	3.9 3.9 2.3
24-Hour Immersion (%)	7.9	6.9	8.4	5.7	8.2	7.5
5-Hour Boil (%)	9.8	9.0	10.6	7.6	9.4	9.5
Saturation Coefficient	0.81	0.77	0.80	0.76	0.79	0.79
FREEZE-THAW*						
Unit No.	<u>1B</u>	<u>2B</u>	<u>3B</u>	<u>4B</u>	<u>5B</u>	AVG
Dimensions (as tested) Length (inches) Width (inches) Height (inches)	3.9 3.9 2.3	3.9 3.8 2.3	3.9 4.0 2.3	3.9 3.9 2.3	3.9 3.9 2.3	3.9 3.9 2.3
Freeze-Thaw Durability @ 50 cycles (% loss)	0.15	0.11	0.11	0.08	0.10	0.11
Observations:	Specime	ens showed	no signs of	cracking or	breakage af	ter testing.

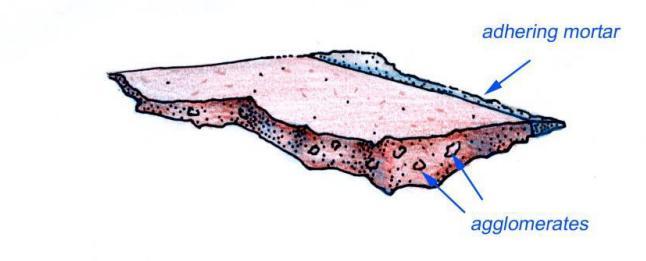
Sample 1: East/South Brick Face

All three samples showed silica as the binding mechanism, thus do **not** appear to have had an applied coating. The sampling fracture planes, following the surfaces in these samples, suggests the silica may have been recrystallized and hardened by subsequent atmospheric exposure

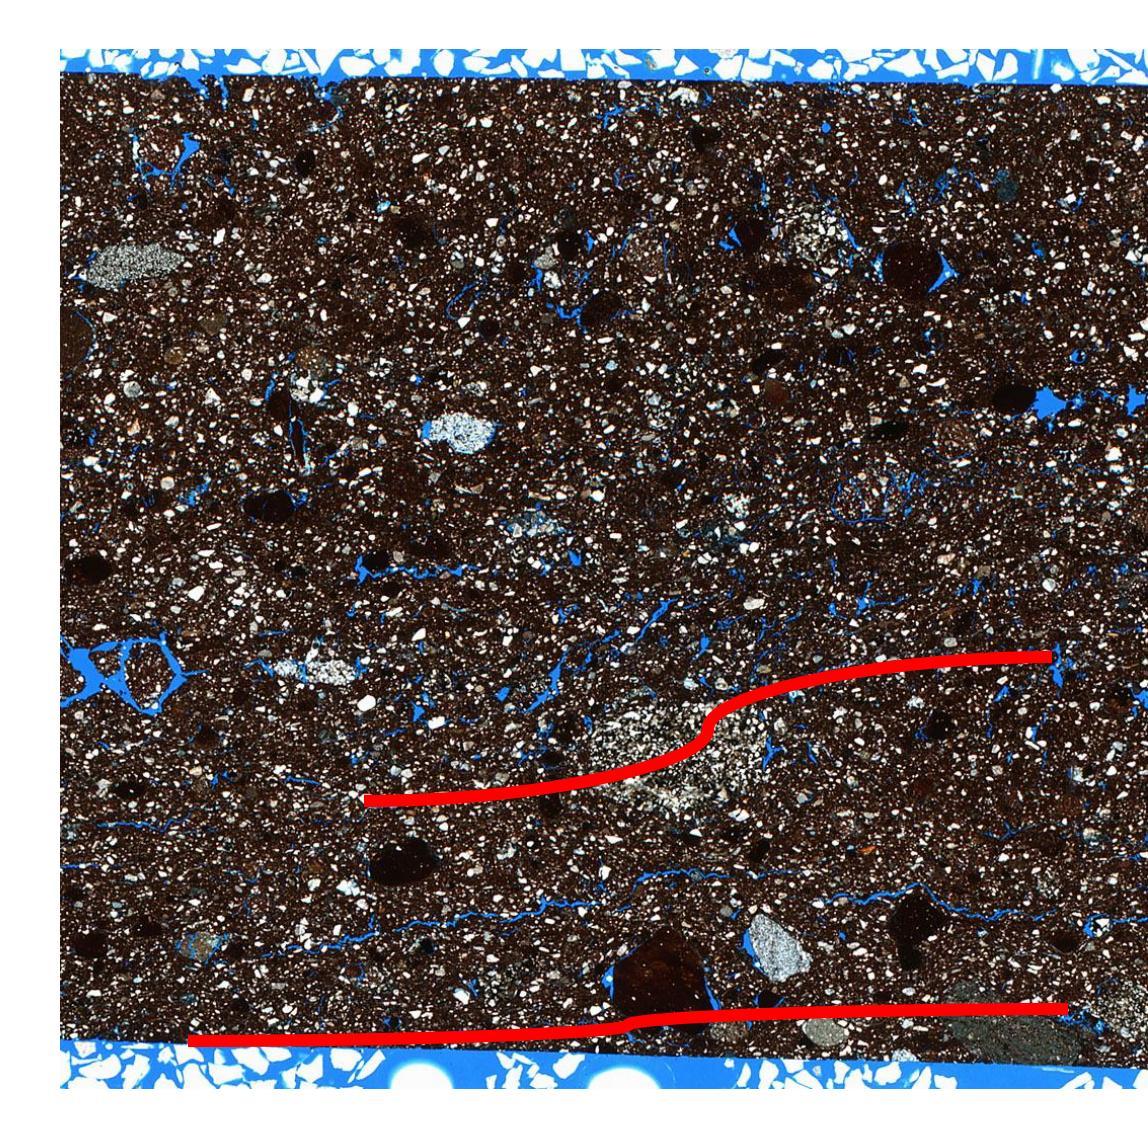
- 1. Failure mechanism inherent in manufacturing process. Likely due to poor bonding of clay during extrusion.
- Low IRA is good and due to small diameter capillaries within brick. However, there is a correlation between small diameter capillary and susceptibility to expansion failures.
- 3. Salts in cement based mortars are leaching into the masonry over long periods of time. Upon drying, expansion of the salts within capillaries causing excessive force.
- 4. Some micro-climate freeze thaw may be occurring but is not the initial cause of failure

Next Steps
- 1. Control water
- 2. 100% repointing with lime based mortar
- 3. Replace all failed brick units
- 4. No sealers need a way for any remaining capillary water containing mortar salts to exit the masonry.
